Eisenhower Park Revitalization

Milford, Connecticut

Environmental Review Team Report

Report #350

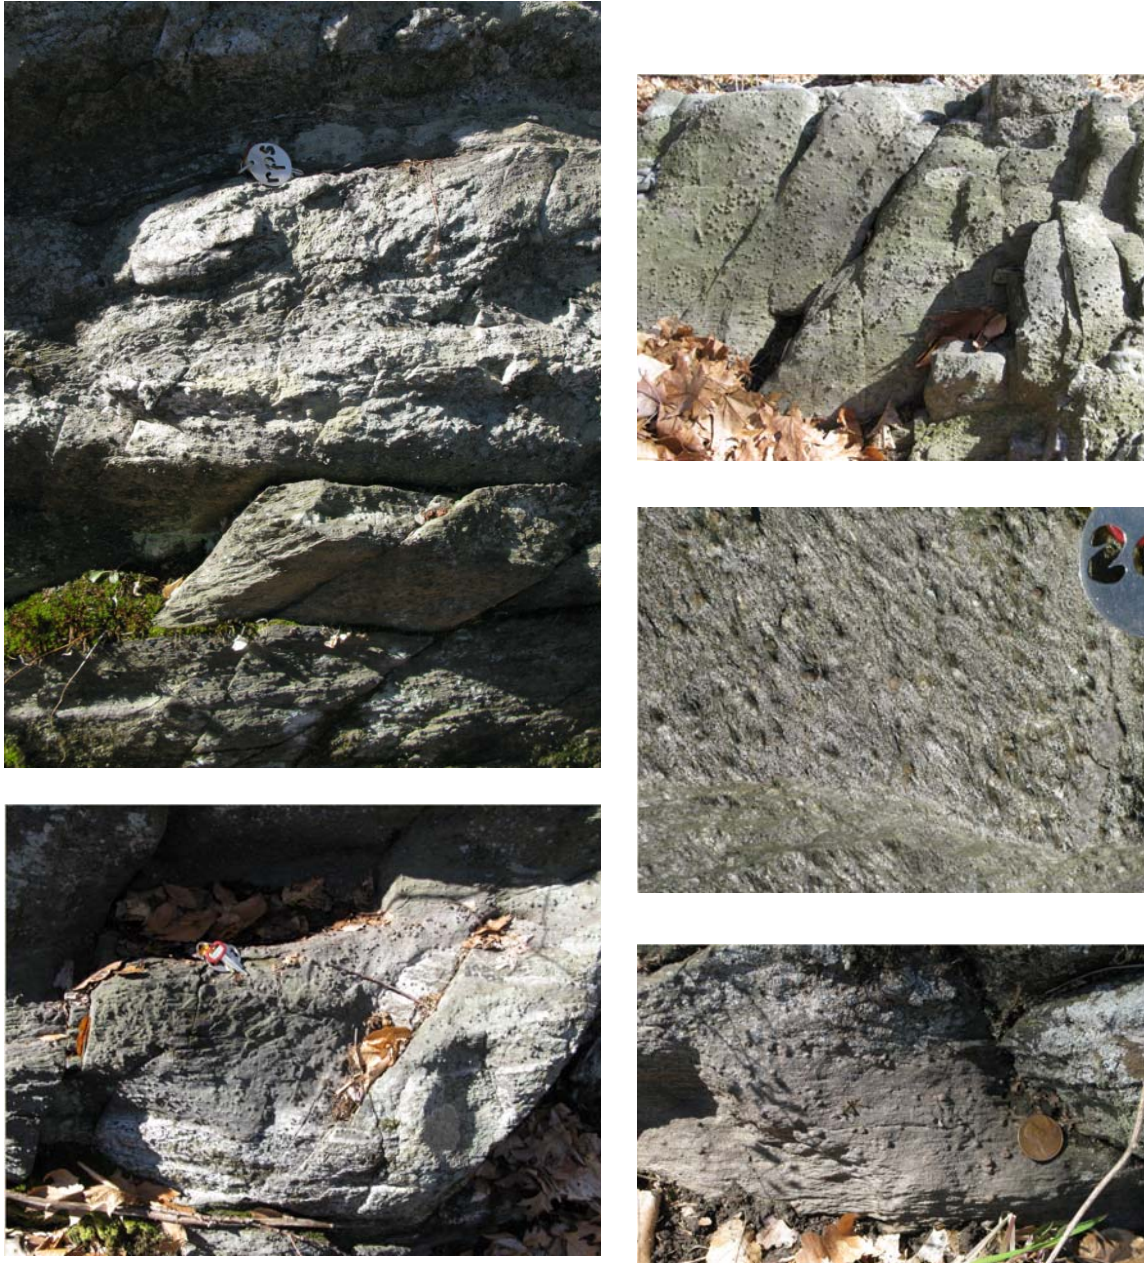
Figure 2. Wepawaug Schist. Upper left shows general concordance of bedding and schistosity seen at most (but not all) exposures (key chain in upper center is 2" in diameter). Lighter layers contain more quartz and feldspar and less muscovite mica. Lower left shows similar stratigraphy. Here garnets are a significant part of the mineral composition. Length of keys just to left and a little above center are 2.5". Right top shows garnetiferous schist. Garnets up to one-half inch in diameter (scale inadvertently omitted: maple leaves are about 4" in diameter). Center right picture shows detail of schistosity (upper left to lower right), garnets and bedding (along bottom of picture) that is cut by schistosity. Letter on key chain disk is about 3/4". Lower right shows bedding (manifest by garnet abundance) and schistosity (penny for scale).

It is gray, dark gray and silvery gray. It consists of muscovite-garnet schist and contains muscovite and garnet with lesser amounts of quartz and feldspar. Some layers contain small amounts of staurolite. Some places graphite is reported, but none was observed during the field

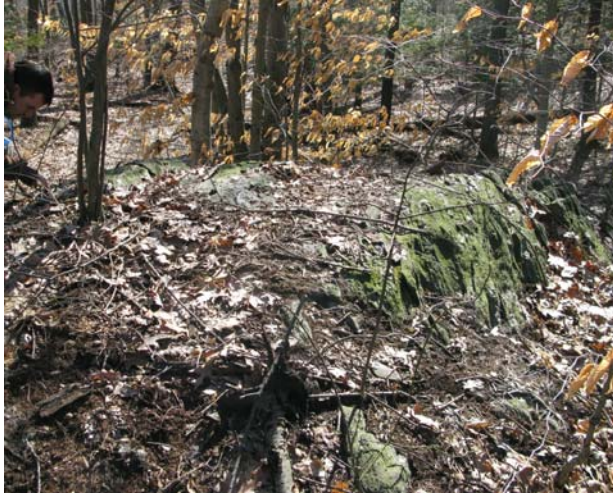
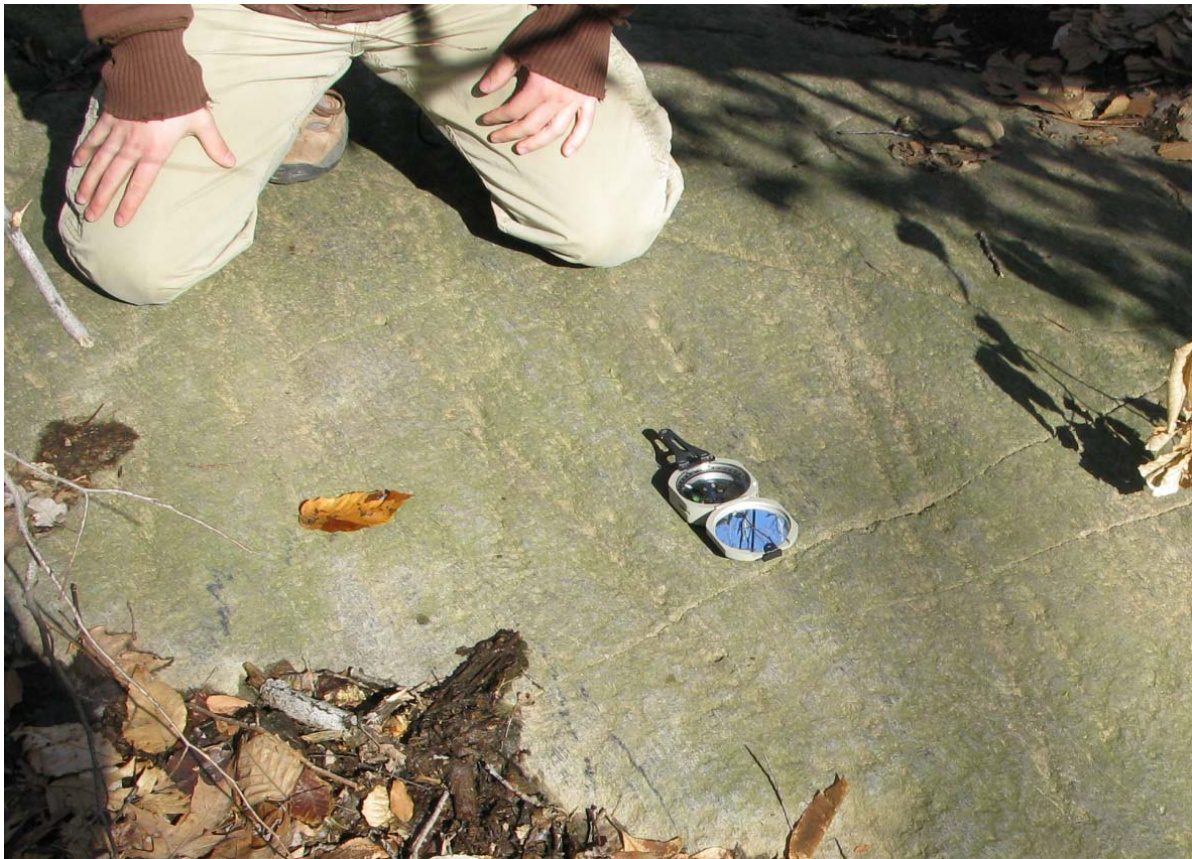
Figure 5. Image at left shows typical bedrock surface that has weathered since deglaciation. The surface although somewhat smooth is rough in detail and no surface marks caused by passage of the glacier remain. Image below shows ledge recently uncovered by construction of a road. The surface is very smooth and has glacial striations that cut diagonally across the outcrop. Notice the line of garnets (foliation of rock) parallel to the side of the compass and at an angle to the striations. Notice also that striations are not parallel to the roadway and hence were not made by bulldozers. Striations indicate ice movement toward the southwest, parallel to the elongation of the drumlin on the other side of the river.

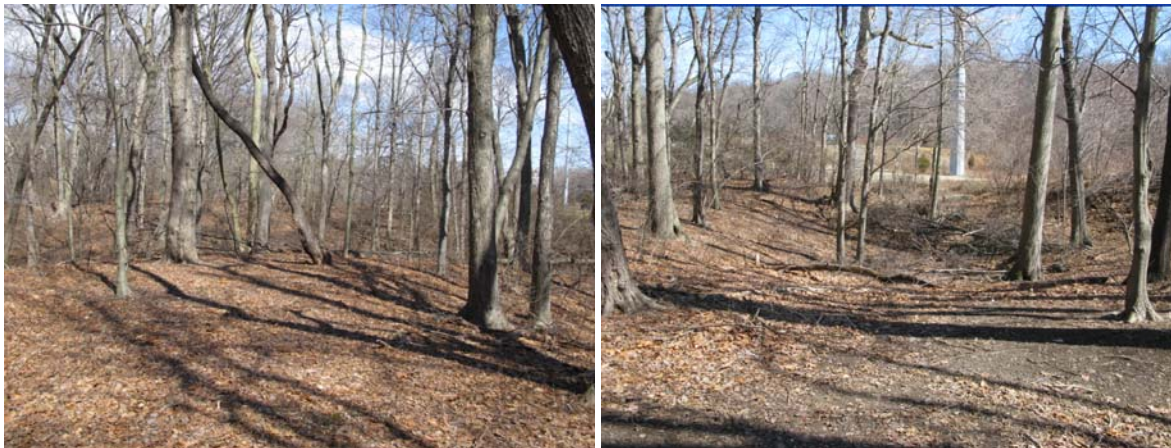
Figure 6. Terrace topography, where undisturbed, is generally hummocky and uneven. Terraces are underlain by sand and gravel that most likely is stratified. The depression on left side of left image is possibly a shallow kettle.

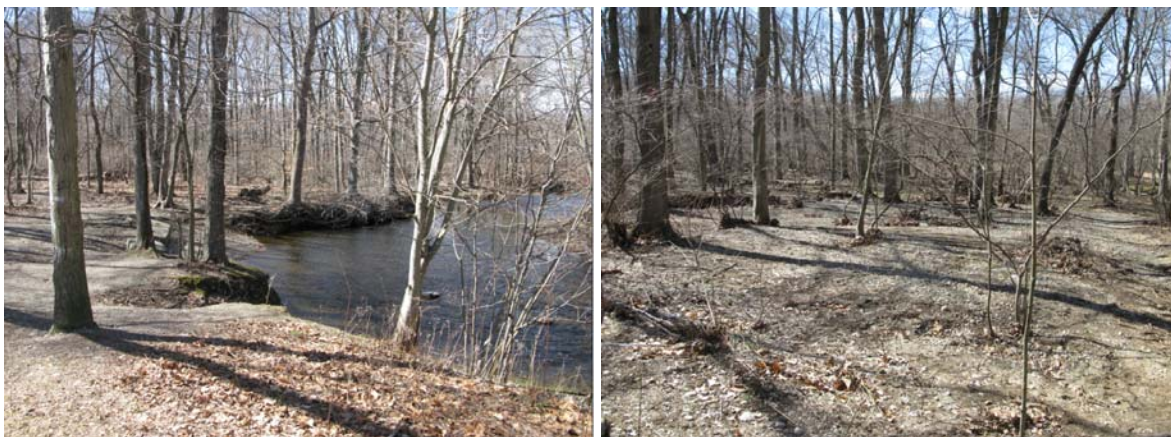
Figure 7. Wepawaug River and its flood plain just downstream from the pond in Eisenhower Park. Images were taken during March, 2009. Moderate to heavy rainfall during December caused minor flooding the extent of which can be recognized in the images by noticing here the past autumn's leaf-fall has been washed away by the high water. Image on left shows bend in the river with typical eroding cutbank on the outer part of the bend and the depositional point-bar on the inner part of the bend (partially obscured by trees on the right).

The modern flood-plain is covered with a veneer of modern alluvium that likely buries older terrace gravel. Minor flooding occurs regularly (Figure 7).

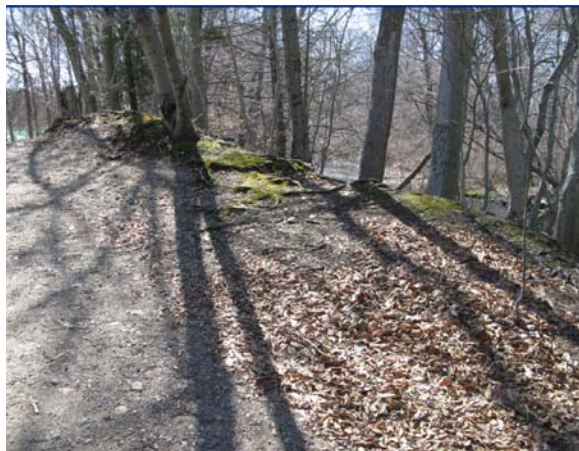
Figure 8. Artificial levee built to a height of 10± feet above flood stage. View taken near south central part of park near a wetland restoration area. Levee continues for about 1000 feet and ends abruptly in a swamp.

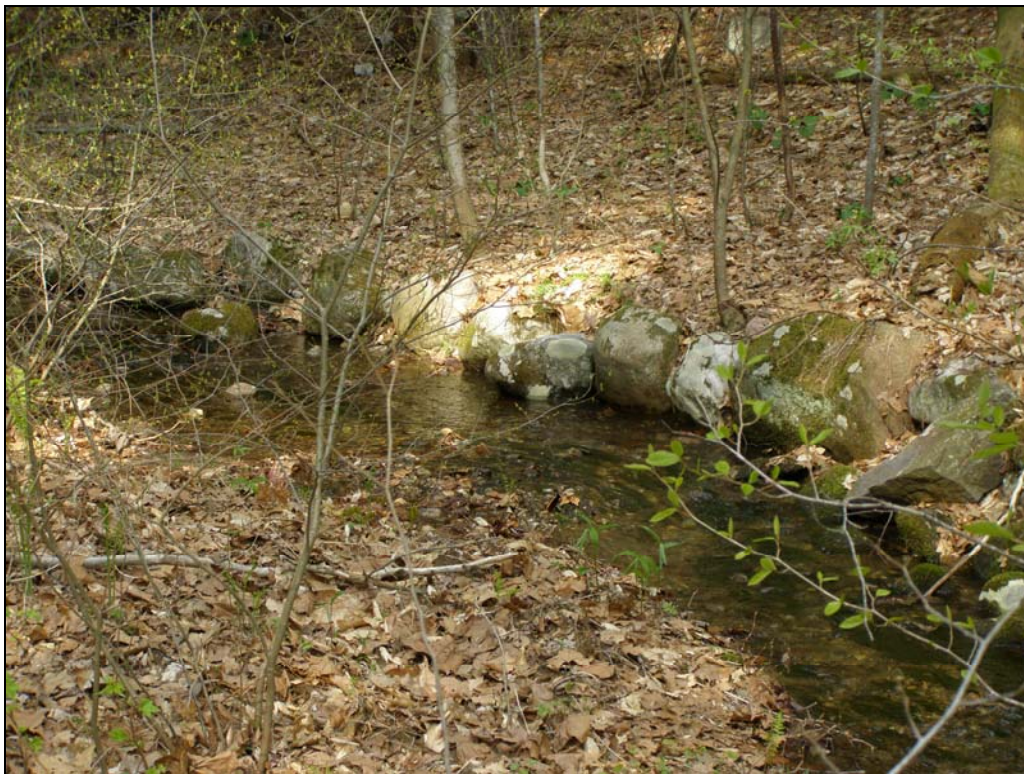
An example of bank placed boulders with reestablished vegetation.

The need for installing measures to abate riverbank erosion was noted in an April 18, 2007 report entitled *Master Plan for Eisenhower Park City of Milford, CT* prepared for the Eisenhower Park Study Committee by Stantec Consulting Services, Inc (the Stantec Report). The Stantec Report rightly endorses the use of bioengineering techniques and boulder vanes to stabilize the river banks. A bioengineered technique consists of both a structural or mechanical element (e.g. hard armoring such as bank placed boulders) and vegetative elements working together to stabilize a site-specific condition. The structural components are employed to allow the establishment of vegetative elements while at the same time providing a level of protection for stability.

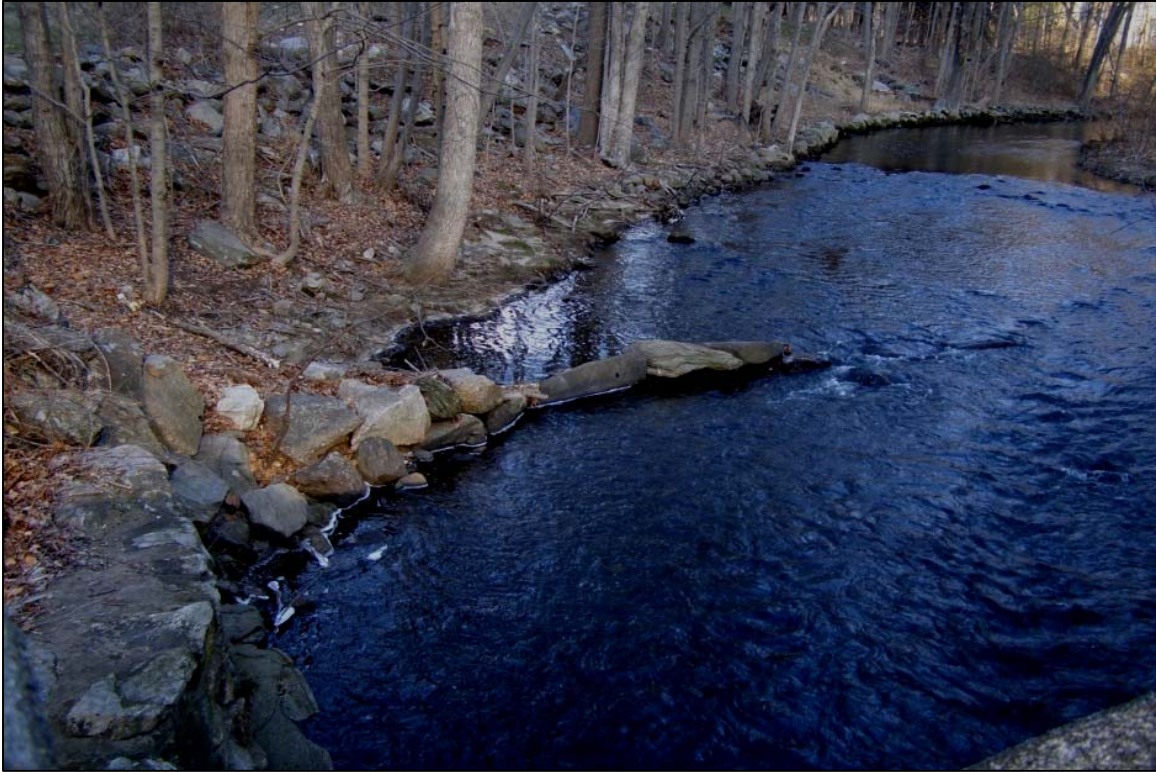
secondary circulation of flow thereby promoting the development of scour pools. Scour pools are critical for fish survival either during low flow periods of the summer months or during the winter when ice may encapsulate shallow water. Rock vanes can also be paired and positioned in a river reach to initiate meander development.

An example of a rock vane.

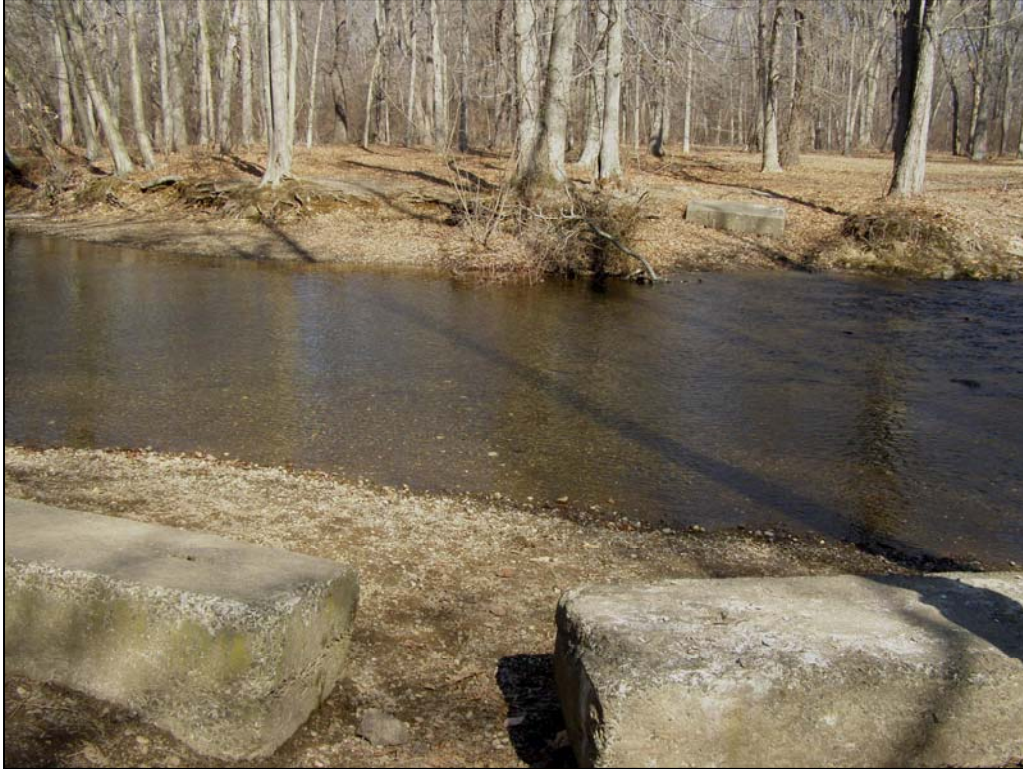
Unauthorized crossing of the Wepawaug River.

The installation of bioengineered bank stabilization and rock vanes require the use of machinery. There is limited access for machinery along most of the Wepawaug River within Eisenhower Park. However, there is one readily accessible area that is in dire need of bank restoration and instream habitat enhancement. The location is immediately downstream of the unnamed pond outlet where horseback riders reportedly cross the river. Apparently unauthorized (as evident by the City of Milford's installation of large concrete block as a barricade) there is evidence of continual crossing. The banks are completely worn, there is a minimal growth of riparian vegetation, and the instream habitat lacks diversity. The site is ideally suited for rebuilding the banks with boulders, organic soil and vegetation along with a series of rock vanes to enhance instream habitat and create a meandering flow pattern

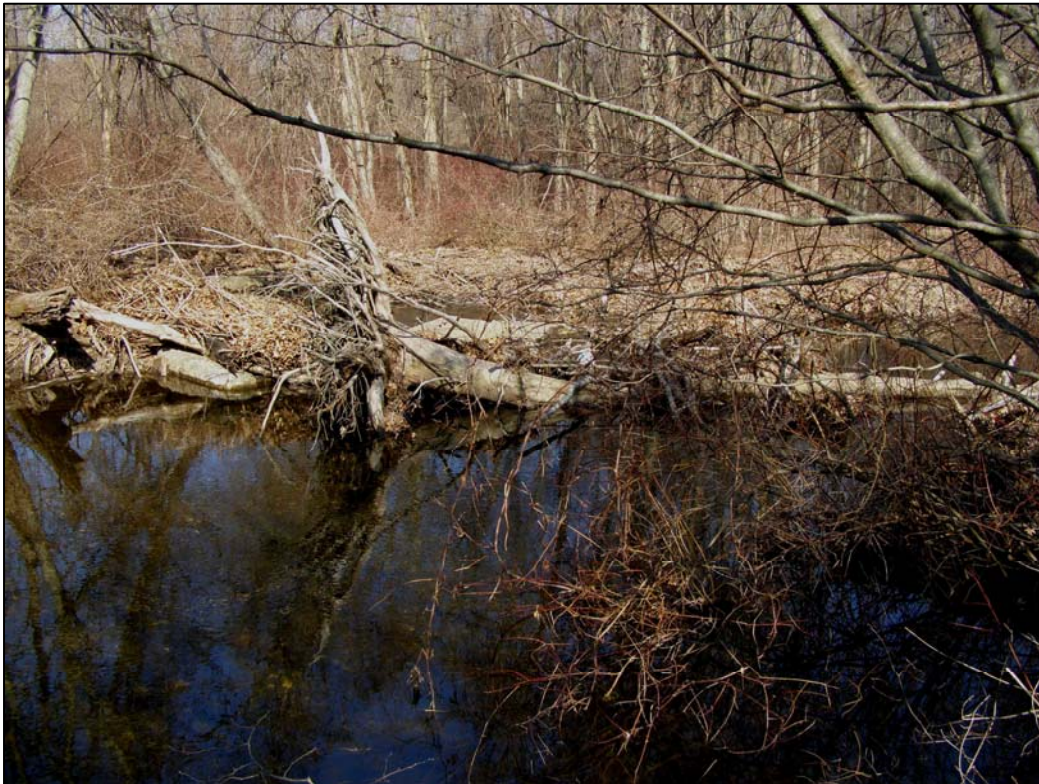
The unnamed pond in Eisenhower Park had been created by excavation with its water supply provided primarily by the diversion of flow from the Wepawaug River. The diversion structure consists of large concrete blocks placed across the river channel that shunt a portion of the flow into the northern end of the pond. A dam is located at the pond's southern end. The dam consists of staked concrete block with a central spillway that is 44 feet in length and approximately 9 feet in width. A low level outlet discharges flow to a channel that ultimately rejoins the Wepawaug River.

**The diversion structure in the Wepawaug River.
View of the structure is partially obstructed by fallen trees.**

2. The crest of the diversion structure should be set at an elevation that allows for the discharge of flows up to the 1.5 to the 2-year storm frequency downstream in the Wepawaug River.

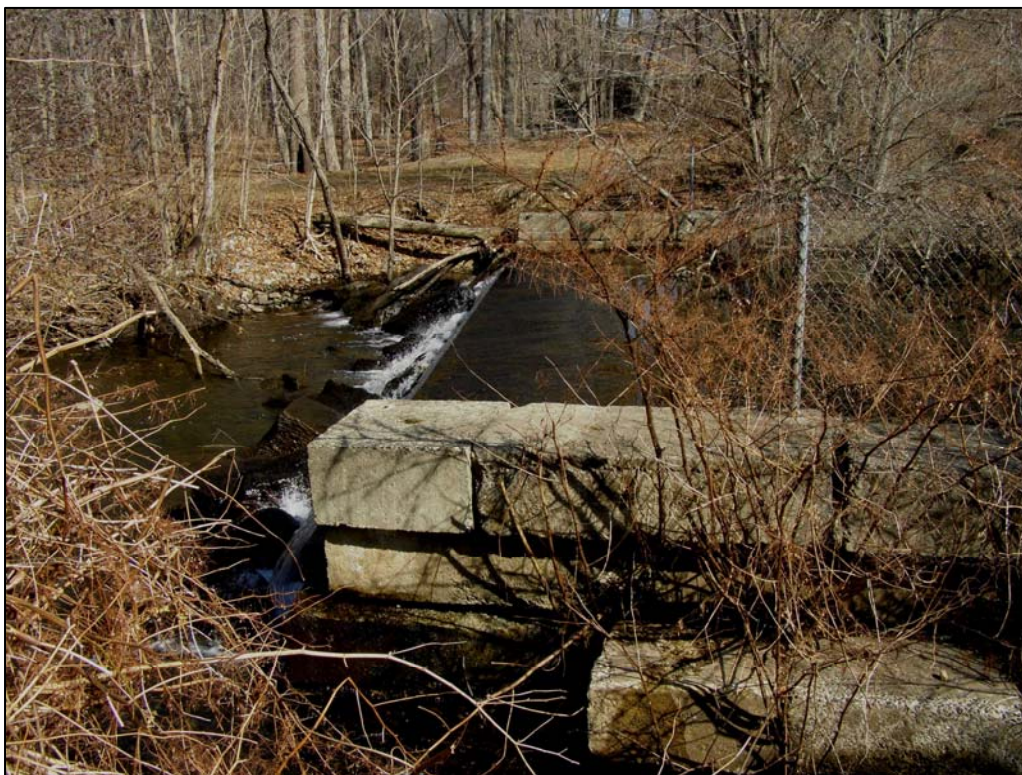
Dam at the outlet of the unnamed pond.

- **Outlet Structure** - The dam spillway and sidewalls are in need of repair and upgrade as an outlet control structure. Once corrected, the dam control device will allow for greater water level control, which would facilitate draw downs to manage aquatic weeds, future dredging operations and access to all structures within the ponds confines.
- **River Inlet** – Periodically isolating flows from the river to the pond for maintenance and flood control would be beneficial to the pond. The control and diversion of in-flow from the river will allow for facility repairs, removal of sediments and restoration of storage capacity.

1. A water control structure should be incorporated into the dam so that the water surface elevation in the pond can be actively controlled. The invert of the water control structure should

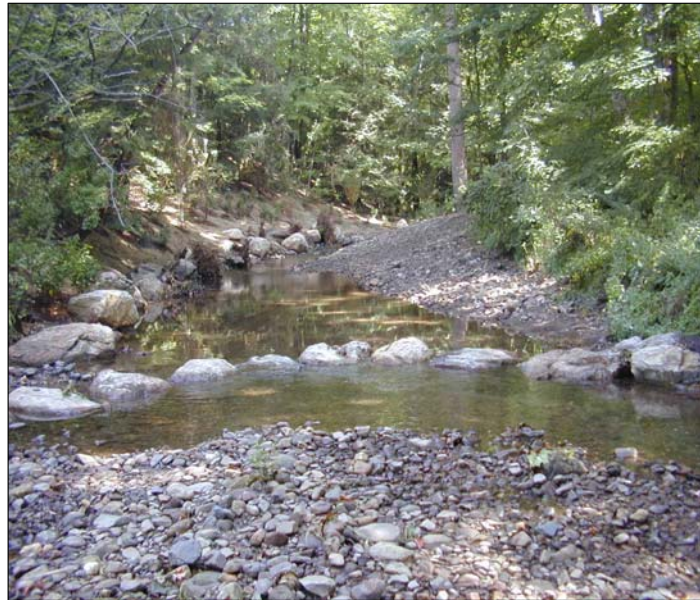
An example of a vortex rock weir.

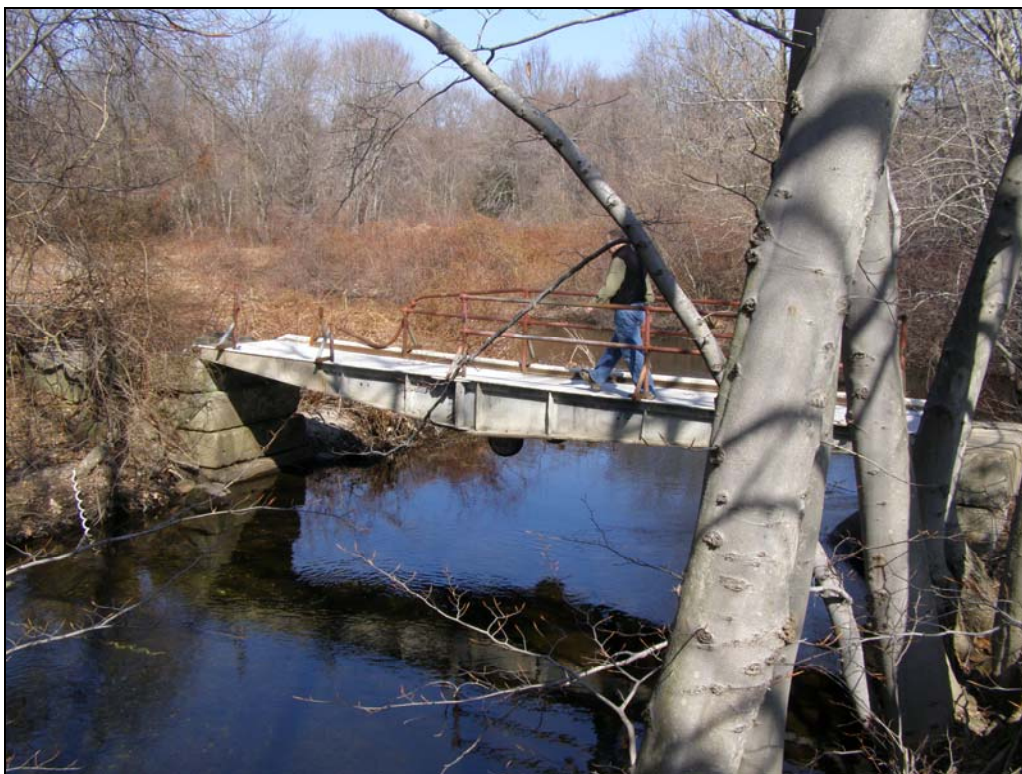
“South bridge” over the Wepawaug River within Eisenhower Park.

The Stantec Report indicates that the “north bridge” is in generally fair condition however, repairs are necessary. Short term recommendations are the replacement of the existing railing while long term recommendations are for a complete replacement. The “south bridge” is in poor condition; it has been recommended that the bridge either be replaced or removed entirely depending on the intended need for the crossing. The Stantec Report had recommended the bridges be rehabilitated and/or replaced in Phase I of a three phase plan for park improvements.

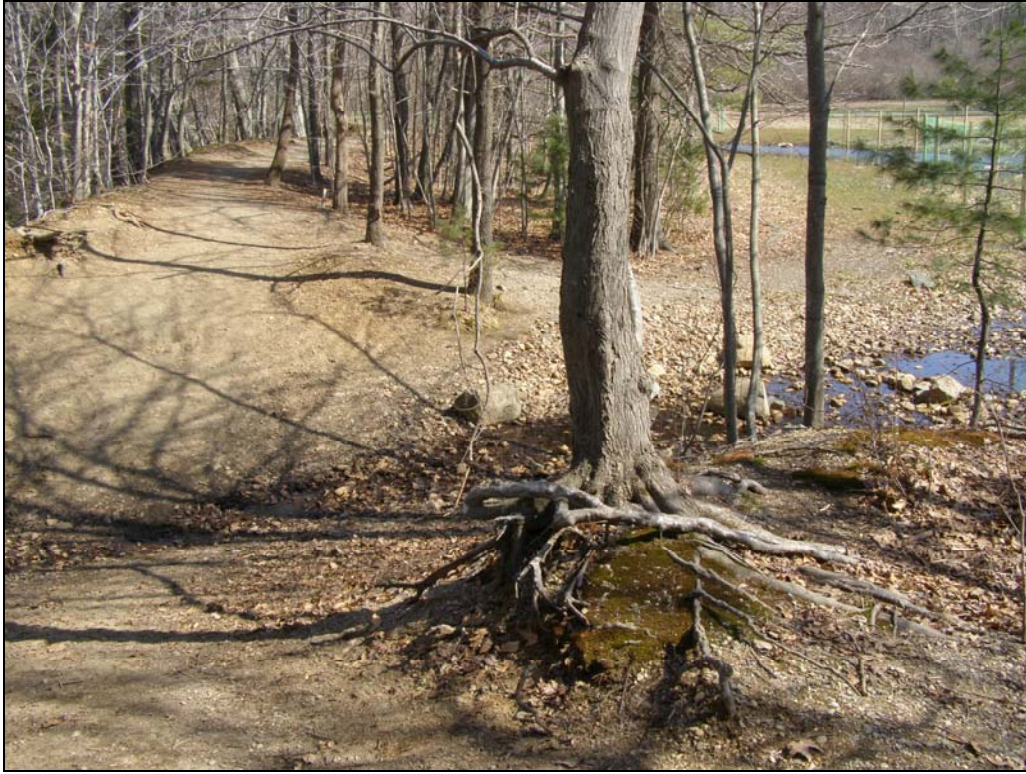
Trail crossing of the outlet of a drainage to the Wepawaug River within Eisenhower Park.

The Stantec Report had recommended trail improvements, particularly in the former Solomon and Alter properties, in Phase I of a three phase plan for park improvements.
